Monitoring Completed Navigation Projects Program

# Burns Harbor, Indiana, Monitoring Study

Volume II: Detailed Approach and Results

Technical Editors David McGehee, Terri Prickett, WES Heidi Moritz, Chicago District

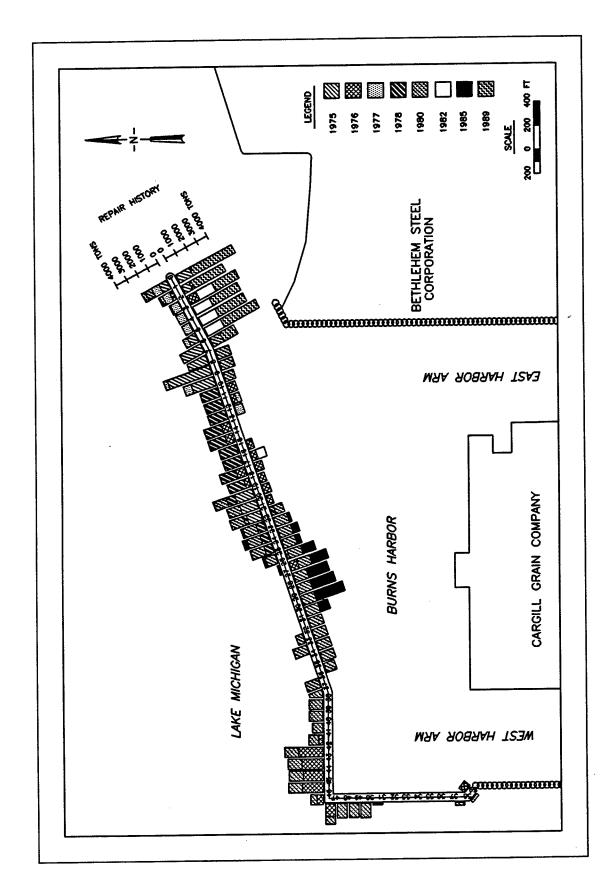
Figure 1-15. Breakwater repair history

Table 1-3 Annual Cumulative Repair Stone Placed, Tons						
Year	Harborside	Lakeside	Total			
1975	2,028	14,703	16,731			
1976	6,463	10,555	17,018			
1977	1,373	8,904	10,277			
1978	0	14,345	14,345			
1980	20,944	26,385	47,329			
1982	6,957	0	6,957			
1985	11,083	750	11,833			
1989	19,477	1,150	20,627			
TOTAL	68,325	76,792	145,117

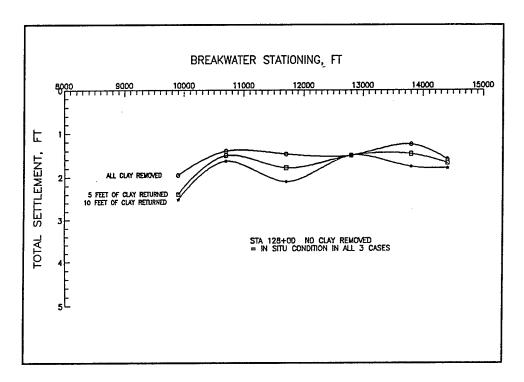
Figure 4-19. Computed settlement for possibility that clay was washed back into foundation excavation prior to sand backfilling (two cases considered)

Three cases of settlement are depicted in Figure 4-19: one case is that all clay was removed and no clay was backfilled; the other two cases plot the contours of probable settlement if 5 or 10 ft (1.5 or 3.0 m) of clay was incidentally returned to the pre-excavated trench and topped with backfilled sand. Settlements range between 1.5 and 2.5 ft (0.5 and 0.8 m). Figure 4-14 shows the settlements for the design condition (all clay removed and foundation replaced by sand). The range of settlement is between 1.0 and 2.0 ft (0.3 and 0.6 m). Figure 4-14 also shows the "in situ condition" if the soils were left unexcavated and no replacement of any foundation soil took place.

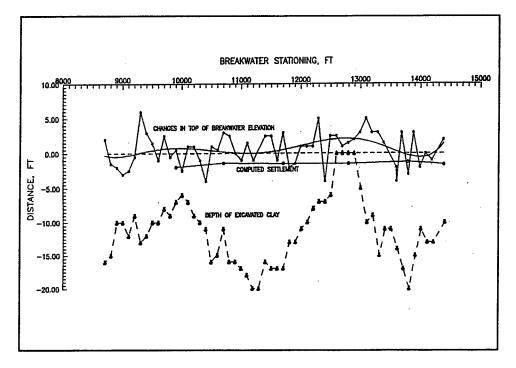
Figure 4-20. Comparison of observed and computed data

Figure 4-20 compares the changes in the breakwater top elevation after the first 8 years of its existence with the depth of excavated clay and the computed settlements for the as-built condition. Changes in the top elevation of the breakwater are represented by the survey data taken along the breakwater center line and by a polynomial curve fitted to the survey data.

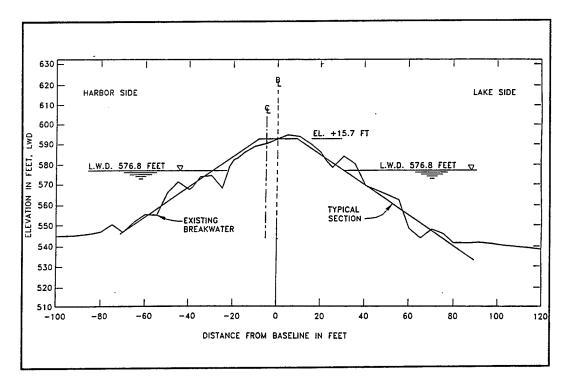
Figure 4-21a. 1985 Survey cross section, Station 23+00

Original calculations of settlement of the Burns Harbor, Indiana breakwater structure were confirmed. Settlement during and shortly after construction probably occurred essentially as expected. This settlement is therefore not apparent in post-construction surveys. Major settlements of the breakwater crest indicated by the 1975 survey are less than 5 ft (1.5 m). The magnitude of the calculated settlements, combined with examination of both as-built cross-sectional surveys of the breakwater and annual cross-sectional surveys taken in 1975, indicate that major rearrangements of the breakwater between construction and 1975 were not due solely to settlement. No effort was made to calculate observed settlement after 1975, when significant amounts of repair stone were added to the structure. It is unknown that settlement has played any significant role in the unsatisfactory performance of the breakwater.

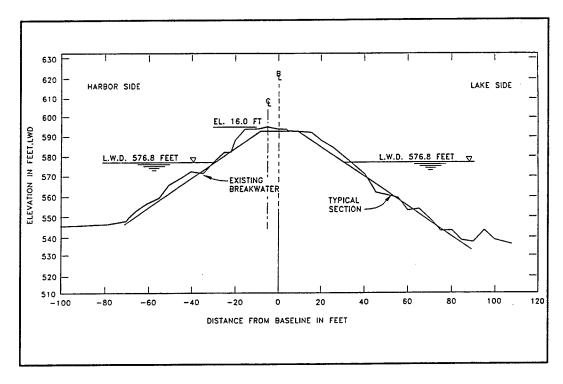
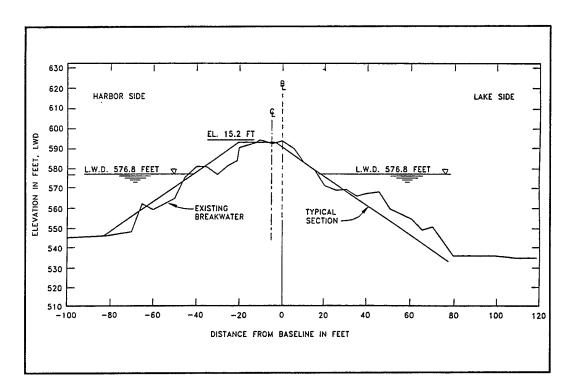
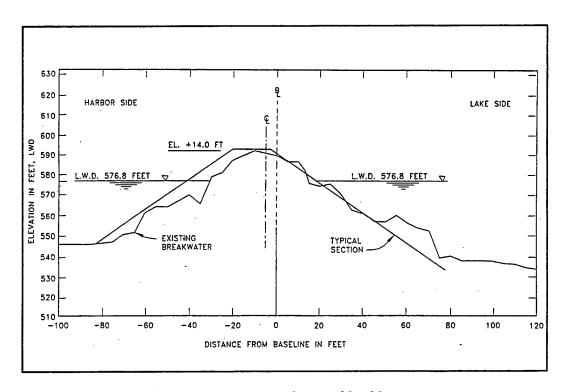
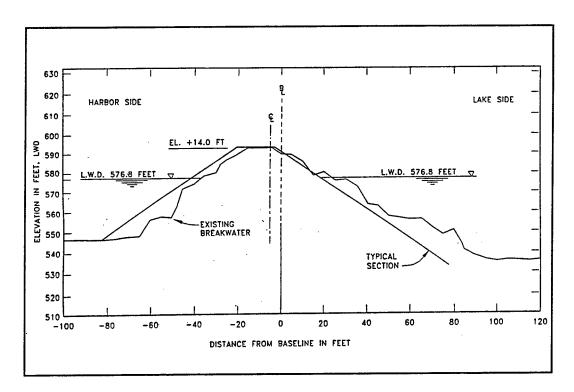
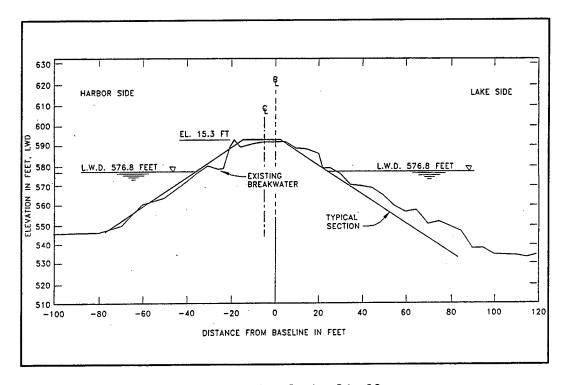
Examination of survey cross sections taken along the breakwater during the first 10 years following construction indicates no discernible or consistent trend in the change of slope or top elevation of the breakwater as observed from Figures 4-21a through 4-21f. The top elevation of the breakwater has subsided a maximum of about 4 ft (1.2 m) in only one or two locations throughout the first 10 years of existence. In other areas, the top elevation of the breakwater has increased probably because of rearrangement of stone blocks by wave action. In summary, the survey data do not appear to reflect a settlement pattern exceeding the order of magnitude predicted by the cases evaluated in this study.

Figure 4-21b. 1985 Survey cross section, Station 24+00

Figure 4-21c. 1985 Survey cross section, Station 26+00

Figure 4-21d. 1985 Survey cross section, Station 29 + 00

Figure 4-21e. 1985 Survey cross section, Station 32+00

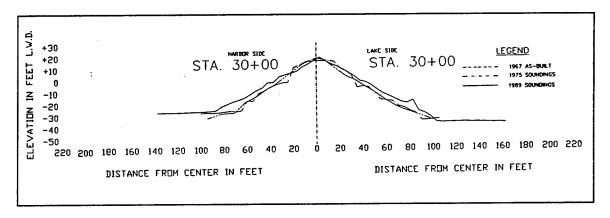
Assessing the 1989 surveys using the control volume approach. In some cases, comparison of previous surveys to the 1989 survey indicated that the overall cross section had gained in area, despite no additional armor stone being placed on the breakwater. The 1989 cross sections appeared to be "swelled" in terms of the below-waterline profile (Figure 5-4). Comparing the 1985 and 1989 surveys in terms of individual cross sections within Segment 2, shows that the 1989 survey exhibited a bias on both sides of the breakwater. No stone was placed on Segment 2 between 1985 and 1989. Clearly, Segment 2 should not have increased in size (area) if no stone was placed on this part of the breakwater.

Figure 5-4. 1989 breakwater profile showing distortion below waterline

The 1985 surveys were conducted using a sounding basket and exhibited a much better indication of actual breakwater slope relief. The 1989 structure surveys were conducted using a fathometer (Bludworth ES130) and produced results which exhibited a relatively smooth profile for each breakwater cross section. Incidentally, the same type of fathometer was used for the 1975 structure survey which produced a much better (irregular) resolution of the breakwater profile than did the 1989 survey. When the 1975 survey was compared to that of 1967, no observable trends of bias were detected. The Bludworth ES130 fathometer was considered state of the art in 1975. Use of 15-year-old marine electronics in 1989 may have been the source of the bias for that particular survey.

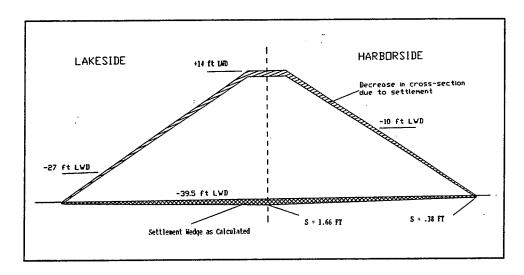
Figure 5-11. Expected cross-section adjustment due to settlement

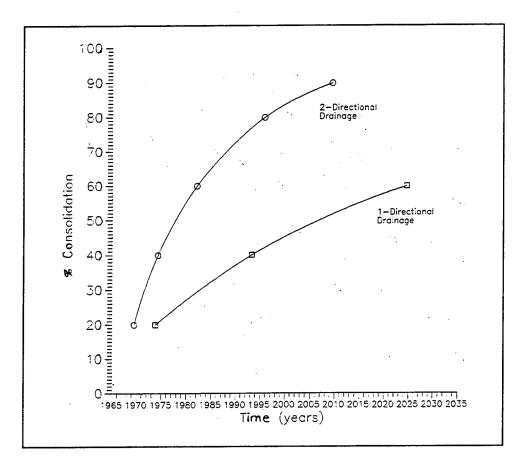
An estimate of the time rate of consolidation was also performed and is illustrated in Figure 5-12. The trend shown in Figure 5-12 suggests that, to date, the breakwater has undergone an estimated 80 percent of its total anticipated settlement. Since experience suggests that the consolidation theory used in this analysis represents an upper limit, it was assumed that essentially 100 percent of consolidation had occurred by 1993<sup>1</sup>.

Figure 5-12. Calculated time rate of settlement

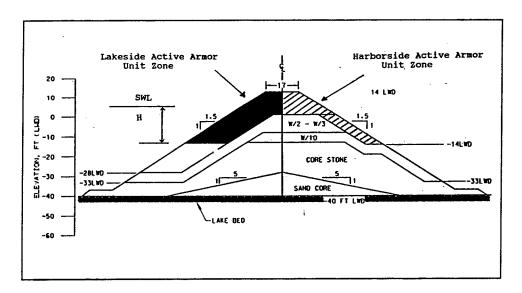
Expected damages were estimated using the design wave height of 15 ft (4.6 m) and a storm water level of +3.5 ft (1.1 m) LWD. Typically, Table 5-17 is used to address lakeside armor layer damages resulting from incident waves approaching perpendicularly to the structure. Figure 5-13 illustrates two areas of the cross section that are susceptible to the predicted damages.

The lakeside active armor unit zone extends from the center of the crest down to one design wave height below the water level on the lakeside. Thickness of the potential damage area is determined by the primary armor unit layers. Since the Burns Harbor breakwater experienced harborside damages also, the harborside armor layer was also used in the damage calculation. The harborside active armor unit zone was composed of one layer of armor to an elevation of -14 ft (-4.3-m) LWD and is also illustrated in Figure 5-13.

Figure 5-13. Active armor unit zone

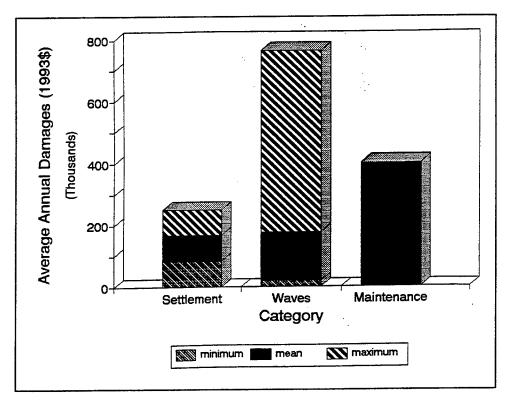
Figure 5-14 illustrates the potential distribution of damages for the two damage modes examined. As can be seen, the degree of variability in the predicted wave damages is higher than in the predicted settlement damages. Another factor affecting the correlation of maintenance and perceived damages to damage mode involves the magnitude of damage. It is not clear how much of a gradual 0.5- to 1.5-ft (0.2- to 0.5-m) settlement reduction in cross section would be addressed by maintenance. Damages due to waves and slope failures are more likely to generate maintenance activities.

Figure 5-14. Theoretical range of damages

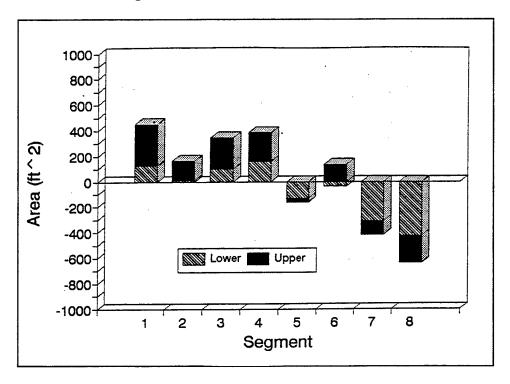
Figure 5-16. Cross-sectional area change of breakwater

The time frame from 1967 through 1989 was used to evaluate the full life of the structure, including total mean damages and total maintenance. Figure 5-16 illustrates the cross-sectional area change over the structure's life in terms of lower and upper area changes. These values were taken from comparisons of surveyed cross sections and examine the first performance issue of actual changes to the structure.

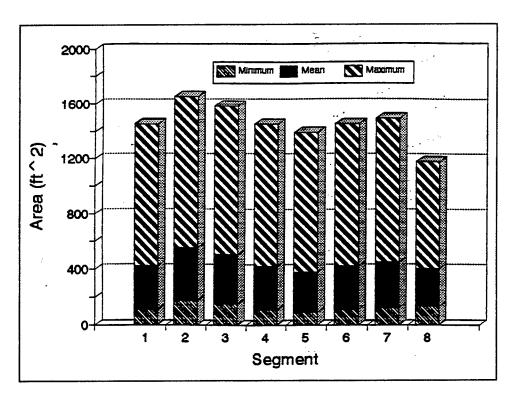
Figure 5-17 illustrates the range in potential damages as calculated from the settlement and wave damage analyses for each segment. The high degree of variability is largely attributable to the randomness of the wave damages. Figure 5-18 illustrates the mean predicted damages due to both settlement and wave damages and the maintenance stone placed per segment. The upper and lower limits of damages indicate the potential range of total damages.

Figure 5-17. Potential damages, wave and settlement

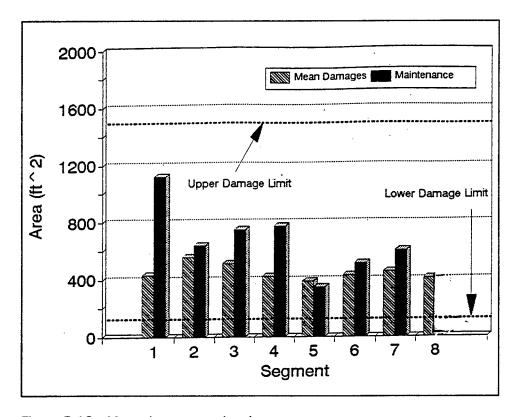
Figure 5-18. Mean damages and maintenance

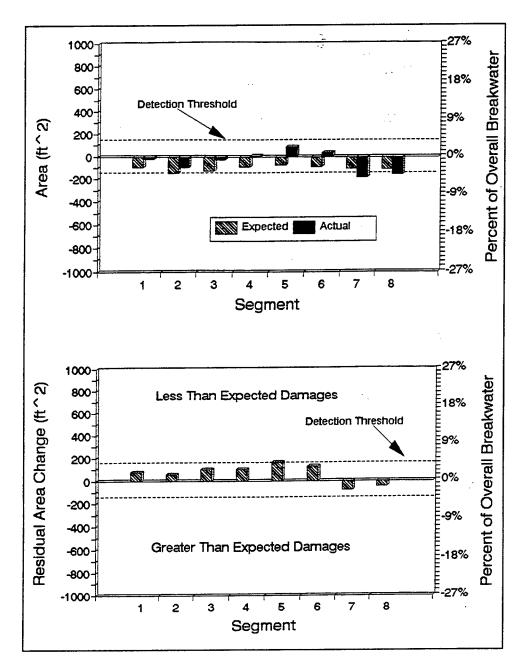
Comparison of cross-sectional area for 1967-1975. The comparison of mean expected to actual changes for 1967 through 1975 is shown in Figure 5-19. The top graph plots actual and mean expected changes to cross-sectional area by segment. The bottom graph plots the residual or the actual change minus the mean expected change. Table 5-26 summarizes values used in this analysis. No maintenance was placed during this time period. Expected changes are a combination of approximately 40 percent of the total settlement and 10 percent of the total wave damages.

All segments show actual positive area changes during this time period except Segments 5, 7, and 8. The largest negative change in area was

Figure 5-19. Area changes and residuals for 1967-1975

Segment 8 with a -14 percent change. Expected trends simulate the actual changes except for Segment 5, which should have exhibited a positive change due to maintenance efforts.

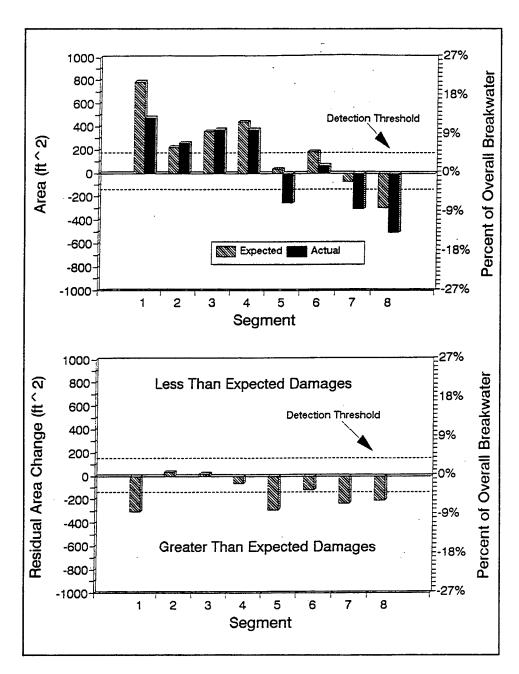
In magnitude, all segments except 2 and 3 exhibited greater than expected damages. That is, actual negative changes to the breakwater were more negative than those predicted by theory under the given environment and actual positive changes were not as great as they should have been, given the maintenance performed. Of those segments, however, four (Segments 1, 5, 7, and 8) were significantly beyond the detection threshold.

Figure 5-20. Area changes and residuals for 1975-1989

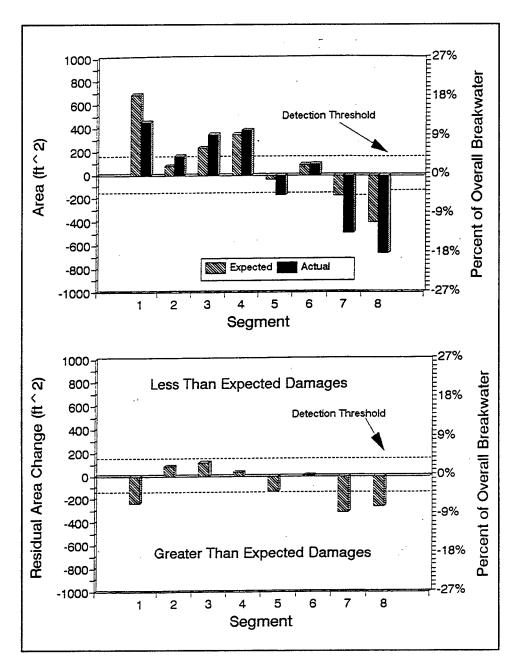
Figure 5-21. Area changes and residuals for 1967-1989

In terms of actual changes, five of the eight segments show a net positive area change ranging from +3 to +12 percent due to maintenance over the life of the structure. Segments 5, 7, and 8, however, show a decrease in area ranging from -5 to -18 percent of the cross-sectional area.

Mean expected changes followed the same trend of change for all segments. In magnitude, no segments had significantly less than expected damages, while four segments (Segments 1, 5, 7, and 8) showed greater than expected damages. Segment 7 exhibits the most critical response over the life of the structure.

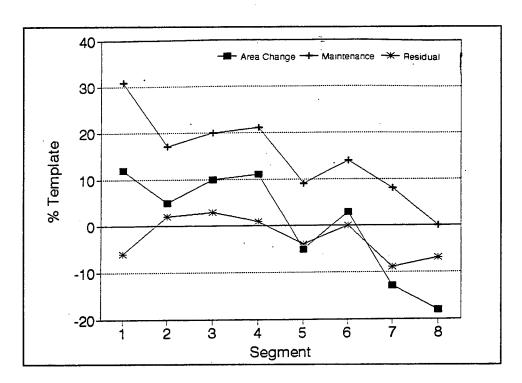
Figure 5-22 illustrates these values in a graphical form. The cross-sectional area change since construction has followed the same general trend as the maintenance since construction along the structure length, indicating a positive correlation between maintenance activity and area change, as would be expected. The maximum area change, however, is only +12 percent of the overall template and three segments exhibit a negative change. Negative area changes along the west end of the structure reflect decreasing maintenance activity for this reach. Maintenance efforts were greatest on Segment 1 decreasing generally in magnitude in the westerly direction.

Figure 5-22. Performance evaluation; area change, maintenance, and residual

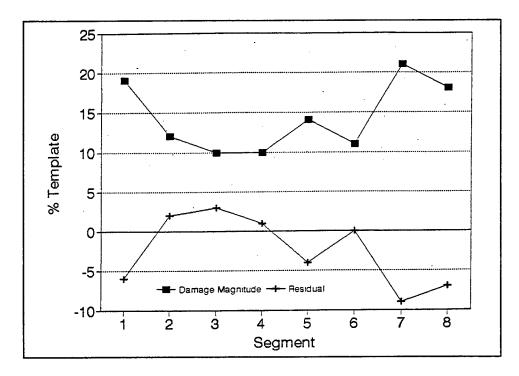
Figure 5-23 plots the damage magnitude against the residual. Looking at the segments individually, those segments with a high damage magnitude (in percent of overall template) and a negative residual are the most critical. Segments 1, 5, 7, and 8 clearly fall into that category. The other segments, while they may have experienced a higher damage magnitude than was expected at the time of the design, have exhibited predictable patterns for both wave and settlement damages.

Figure 5-23. Performance evaluation; damage magnitude and residual
